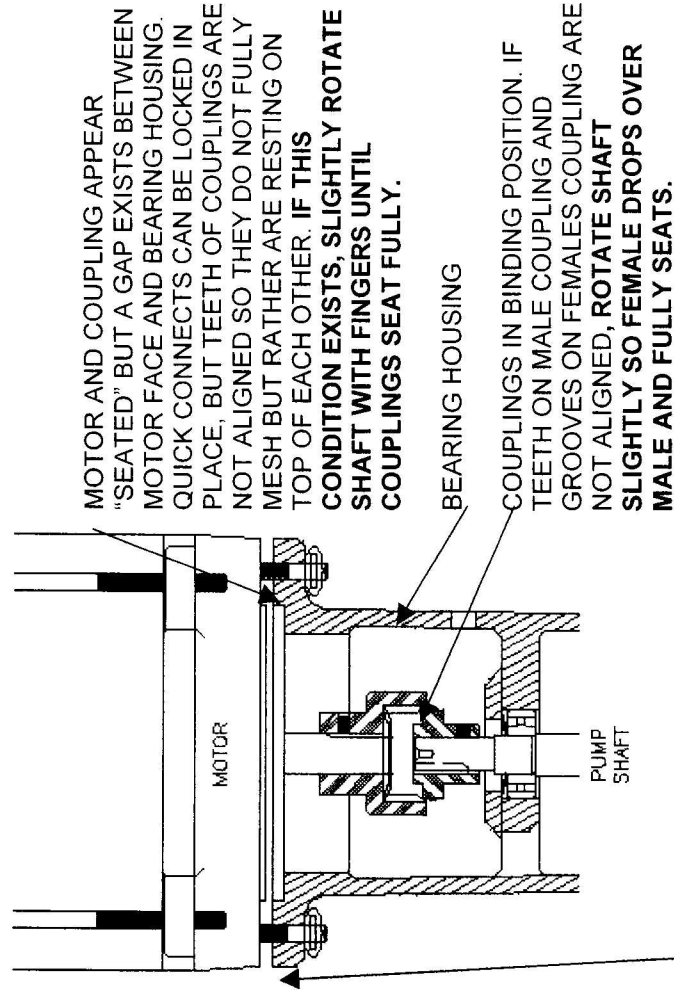
If you note excessive wear in the form of a taper (most obvious on the male portion), you may be experiencing one of the following two Problems:

- 1. IMPROPER SEATING/MESHING OF THE MOTOR AND BEARING HOUSING COUPLINGS**  
MOTOR NOT SEATED COMPLETELY BECAUSE TEETH ARE MISALIGNED.

MOTOR AND BEARING HOUSING SHOULD BE IN CONTACT-NO GAP

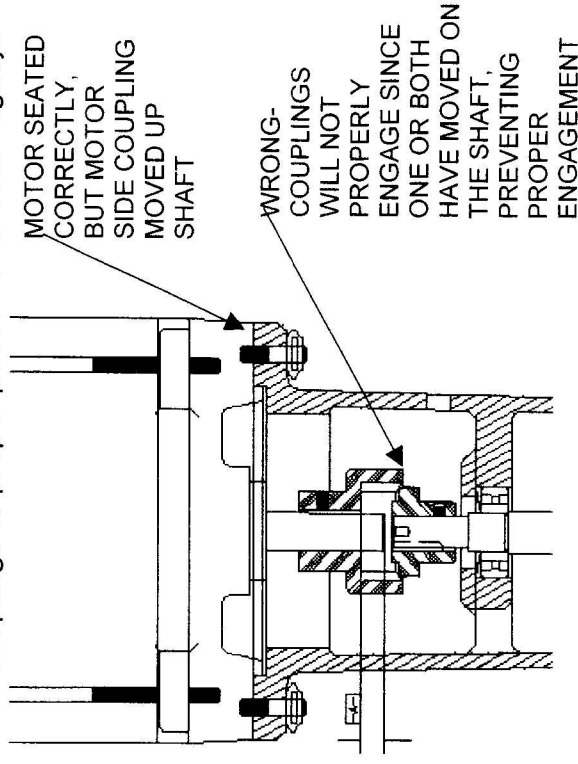
- 2. COUPLINGS HAVE MOVED ON THE SHAFT.**  
This usually happens when the couplings don't mesh correctly and the motor is forced down.  
Move couplings to proper position and fasten tightly.

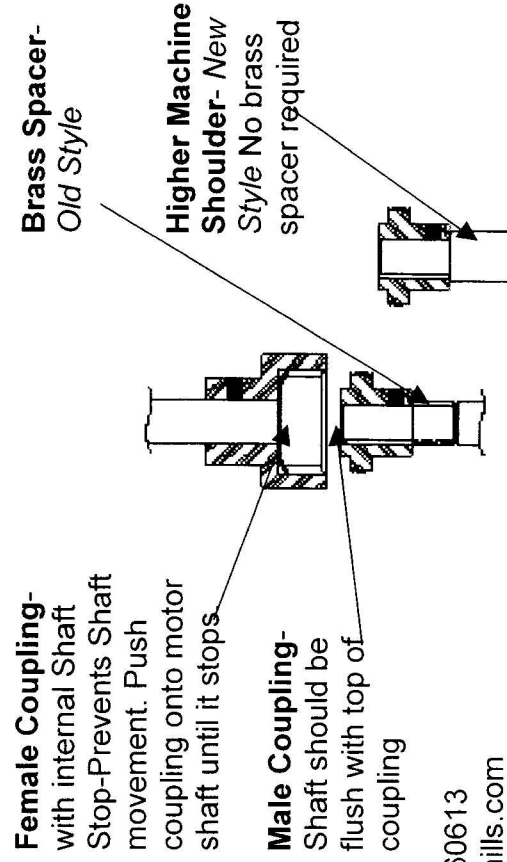
Figure below represents proper installation of coupling set on shafts, and proper mating of both old (brass spacer) and new (shoulder machined into shaft) style shafts.
