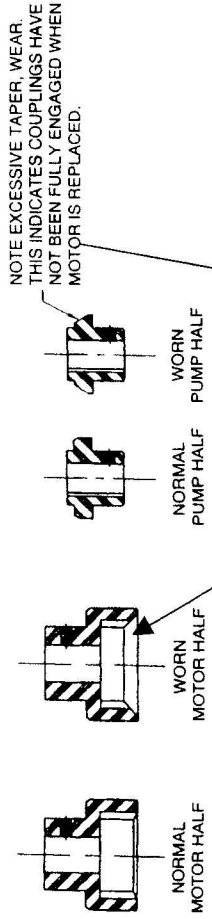
If you note excessive wear in the form of a taper (most obvious on the male portion), you may be experiencing one of the following two Problems:
